**APPLICATION FOR HERITAGE GRANTS FUNDING ASSISTANCE FALL 2017**

**HISTORIC PROPERTY AND ADDRESS:** 708 San Antonio, Austin, Texas 78701

**APPLICANT'S NAME:** Austin Woman's Club

**PROJECT NAME:** Windows Restoration of North-Evans Chateau Fall 2017

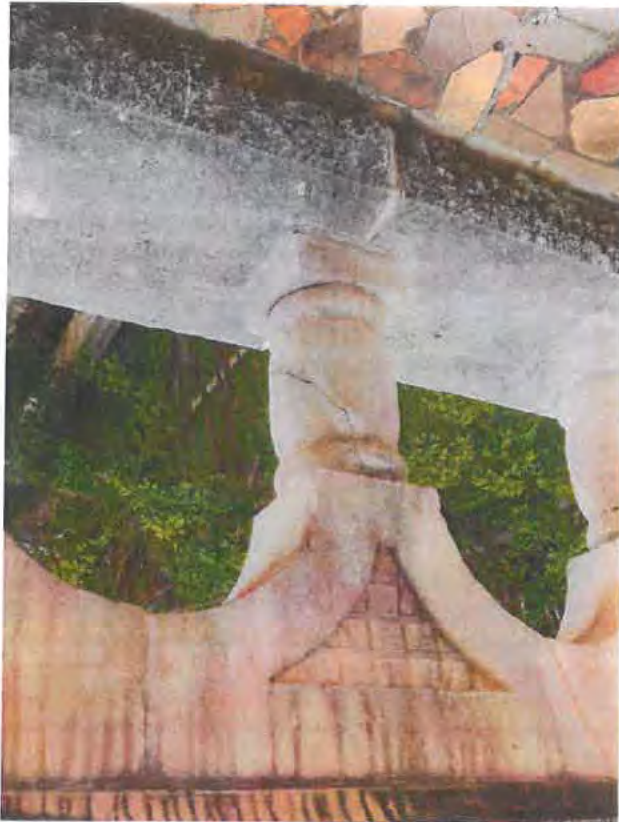
Photo 33: Another example of previously patched central balcony baluster that is cracking.

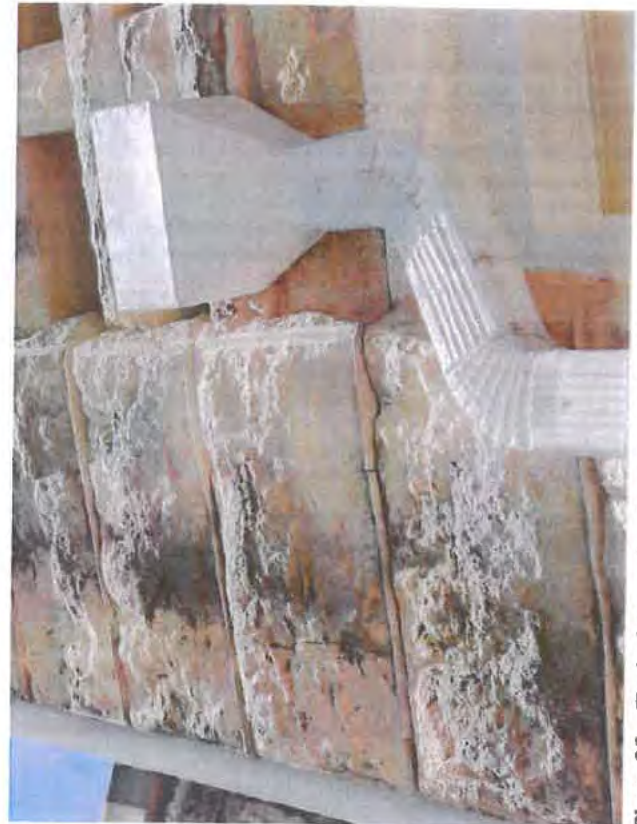
Photo 35: Typical example of cracked and missing mortar. Note cracked stone. Water from portico drain may have caused the window lintel to corrode, causing "rust jacking".

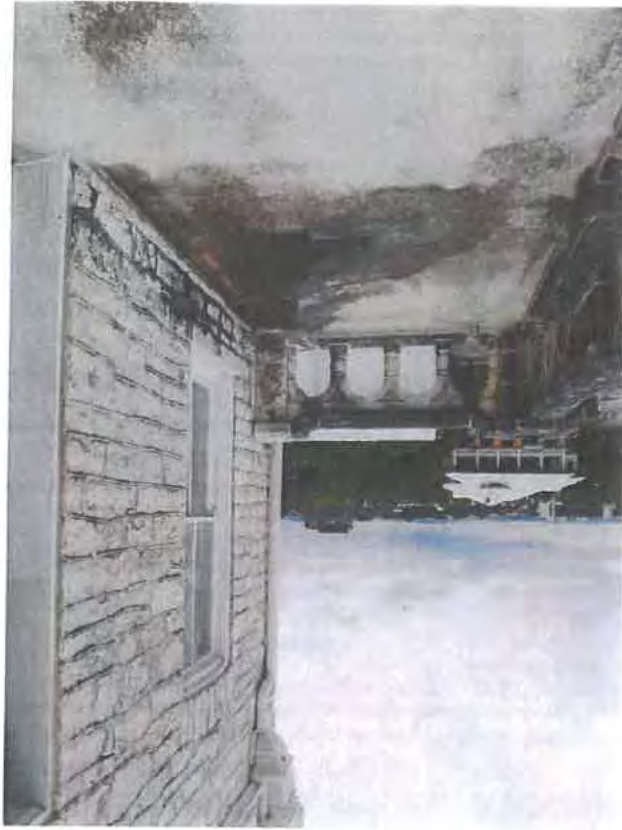
Photo 34: Ponding at the west balcony. Note the biological growth on stone caused by excessive moisture.

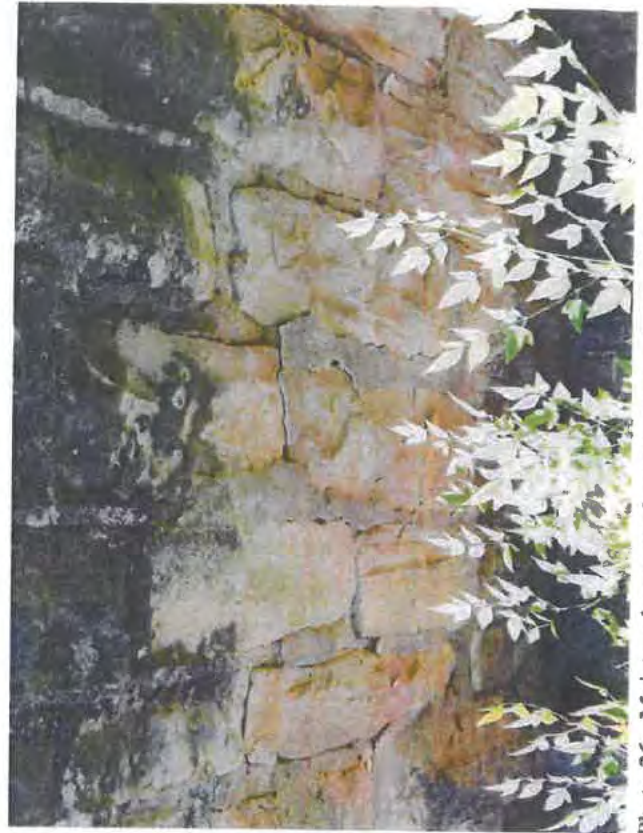
Photo 36: Moisture has caused mortar loss and stone deterioration at this west elevation buttress. Note heavy biological growths and separation of hard repointing mortar.

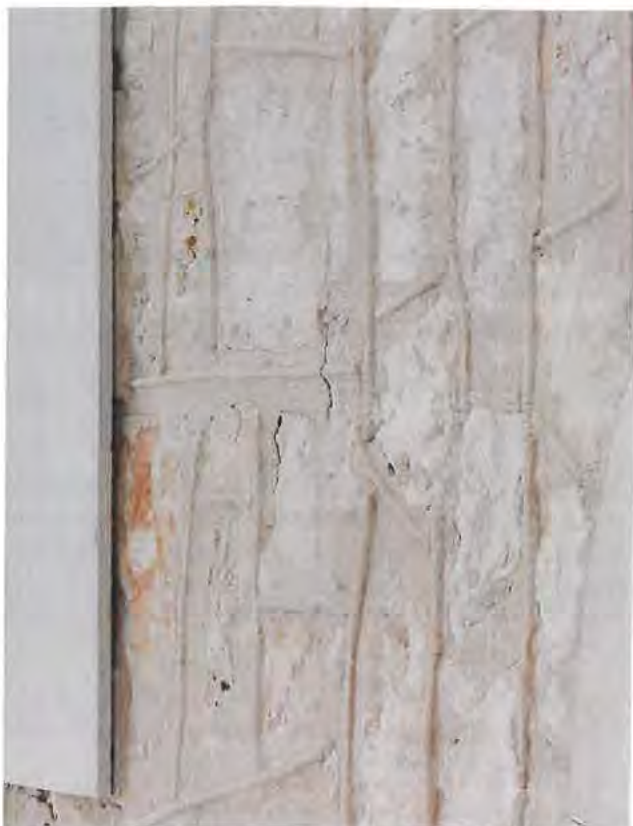
Photo 37: Another example of mortar separating from stone. Note displaced frieze above.

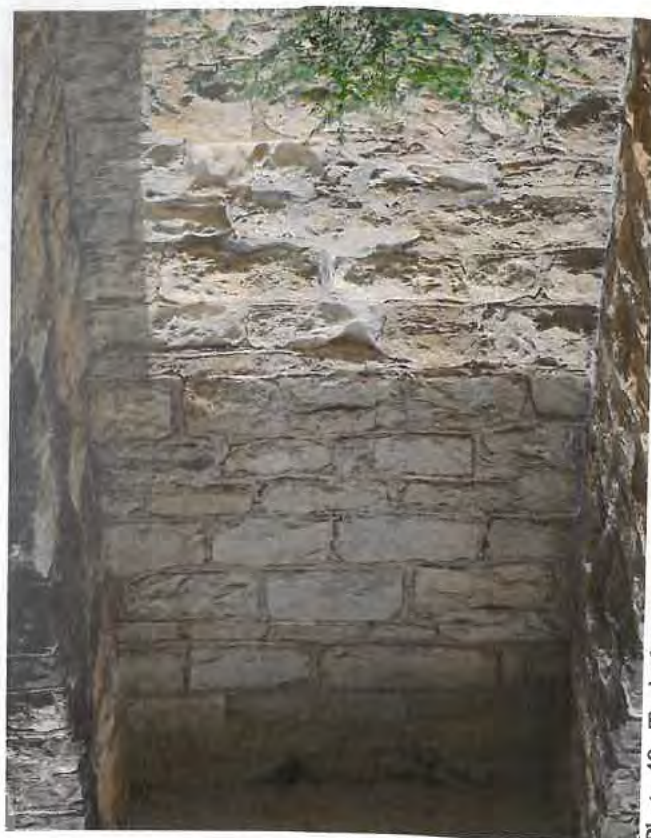
Photo 40: Typical masonry conditions at buttressed west wall.

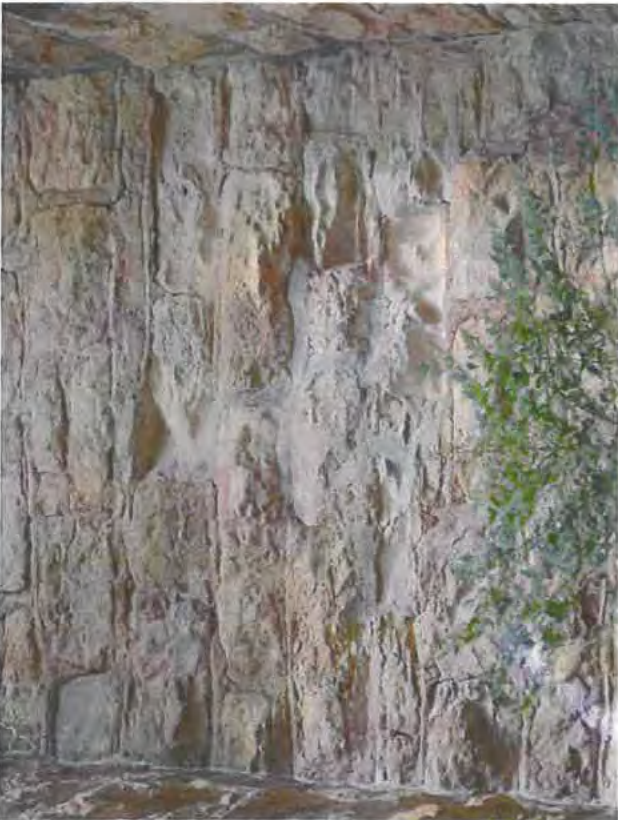
Photo 41: Detail of deteriorated stone and mortar at buttressed west wall.

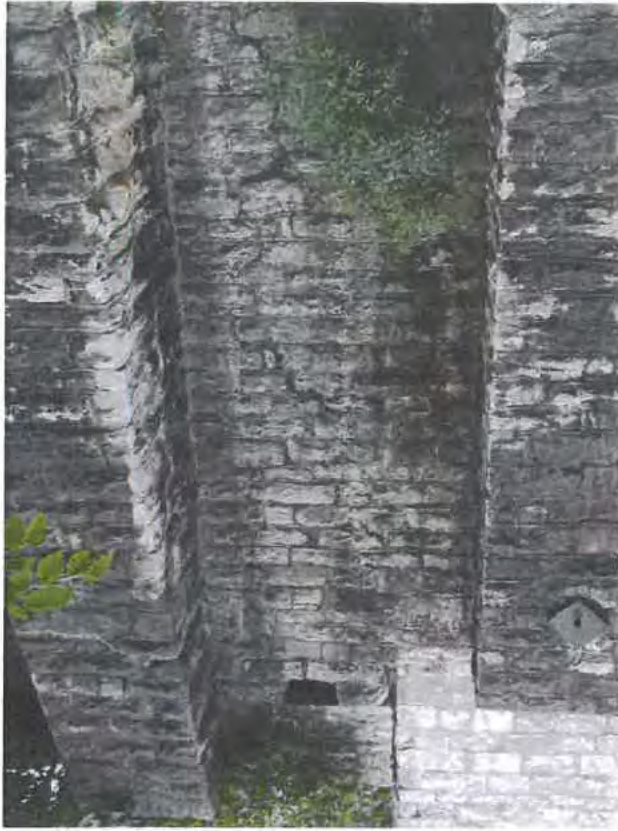
Photo 42: Typical cracking at buttressed west wall.

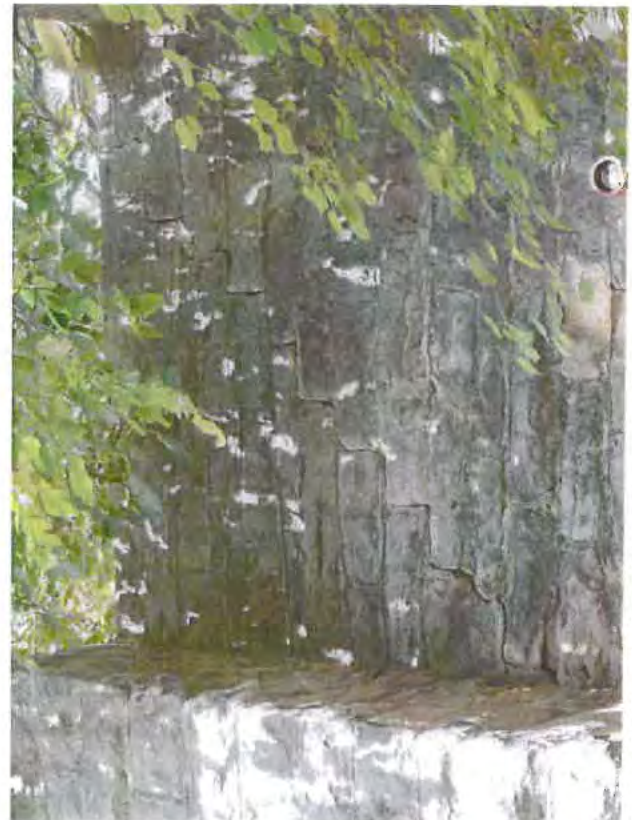
Photo 43: Detail of cracking at buttressed west wall.

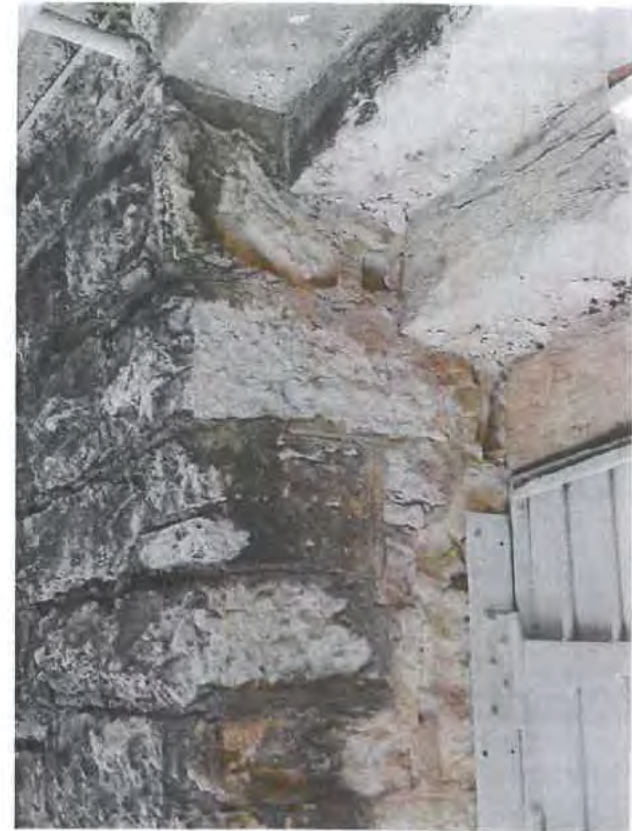
Photo 44: Typical stone deterioration at west wall.

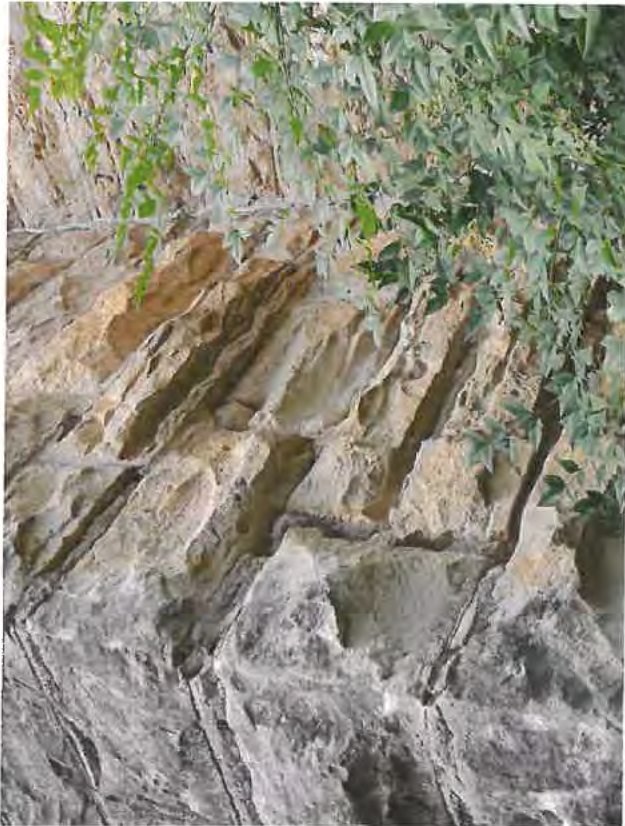
Photo 45: Typical stone and mortar deterioration at west wall buttress. Note sealant applied to joint between buttress and wall.

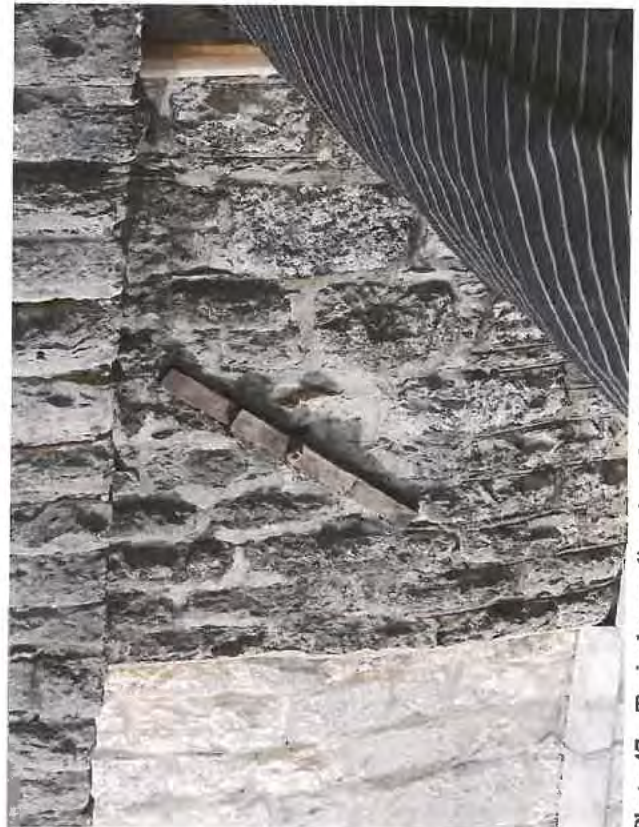
Photo 47: Typical corroding tie rod plate on west elevation.

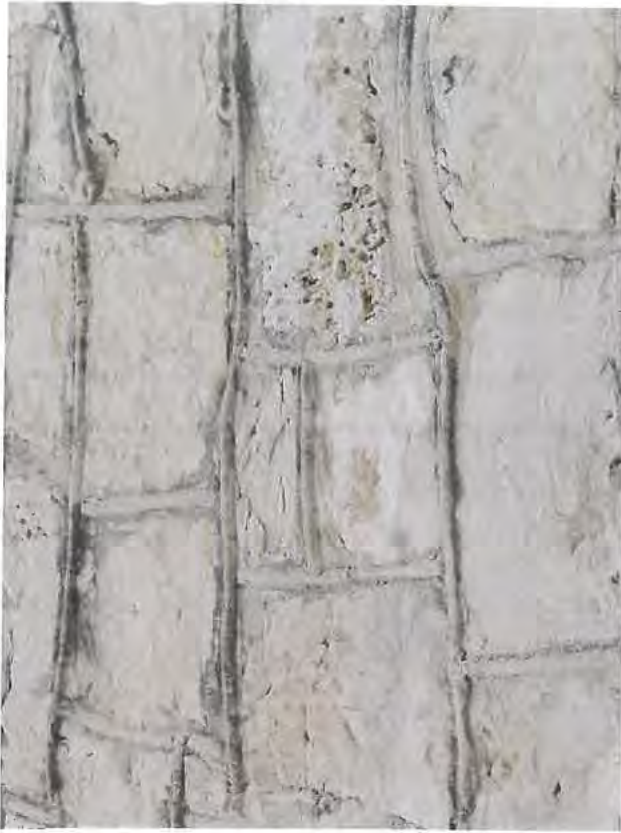
Photo 46: Typical examples of stone delamination (scaling) and stone with alveoles (honeycombing).

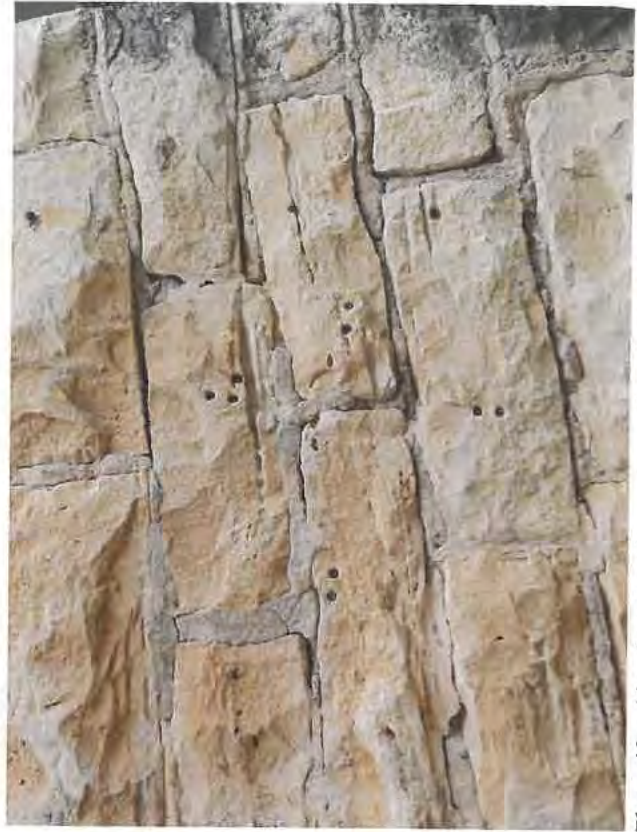
Photo 48: Abandoned anchors at west elevation buttress. Note deteriorated mortar joints and eroding surfaces of stone.

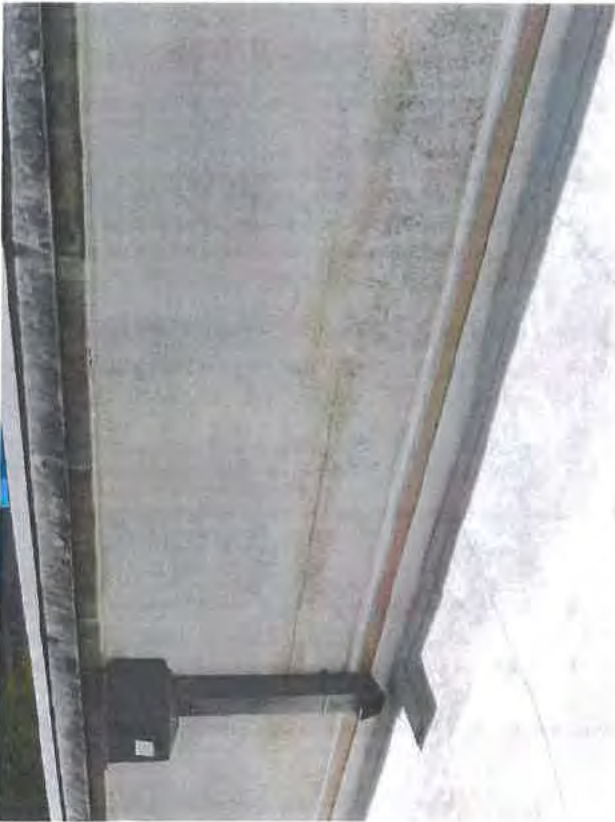
Photo 49: Crack at north wall of Chateau Room.

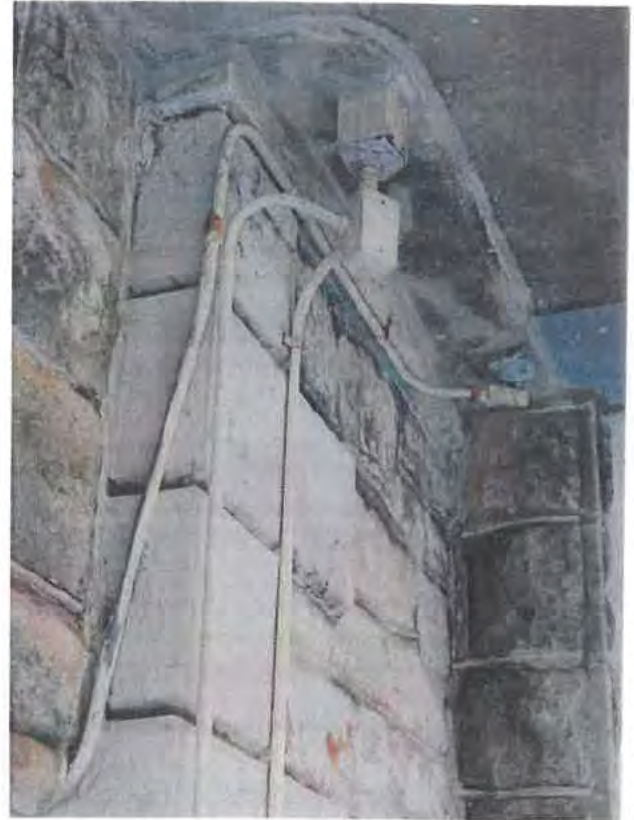
Photo 51: Typical example of corroding conduit anchors and connectors. Note peeling paint on conduit.

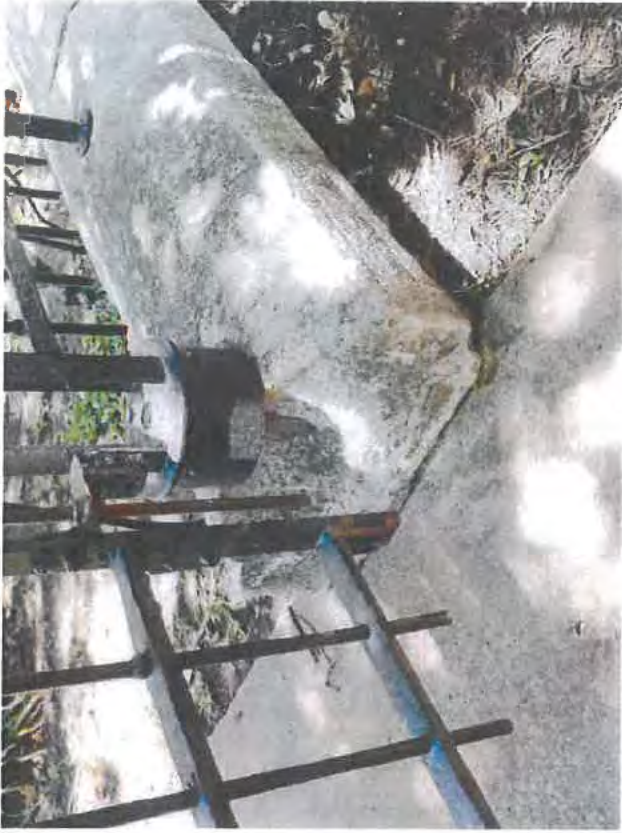
Photo 50: Typical example of damaged stone at gate anchors.

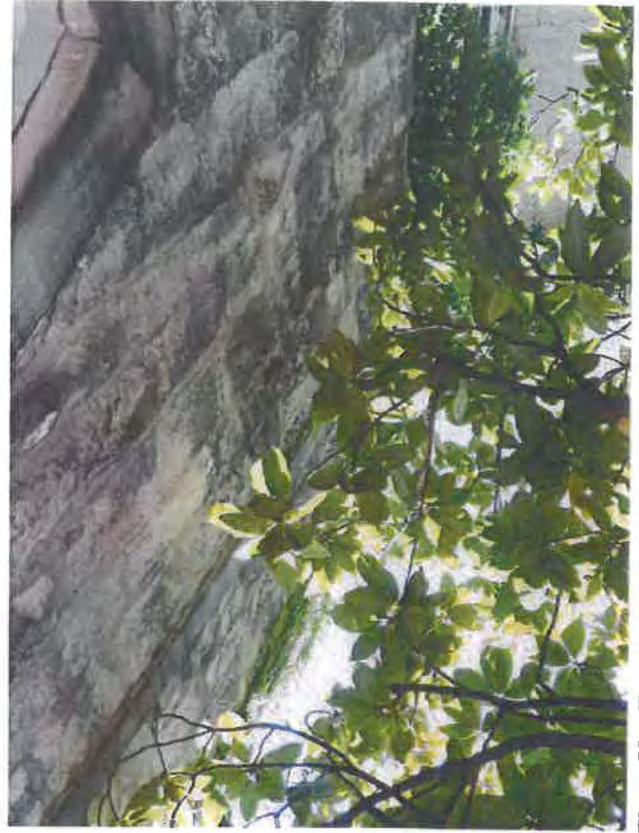
Photo 52: Tree limbs should be pruned so there is no contact with building walls.

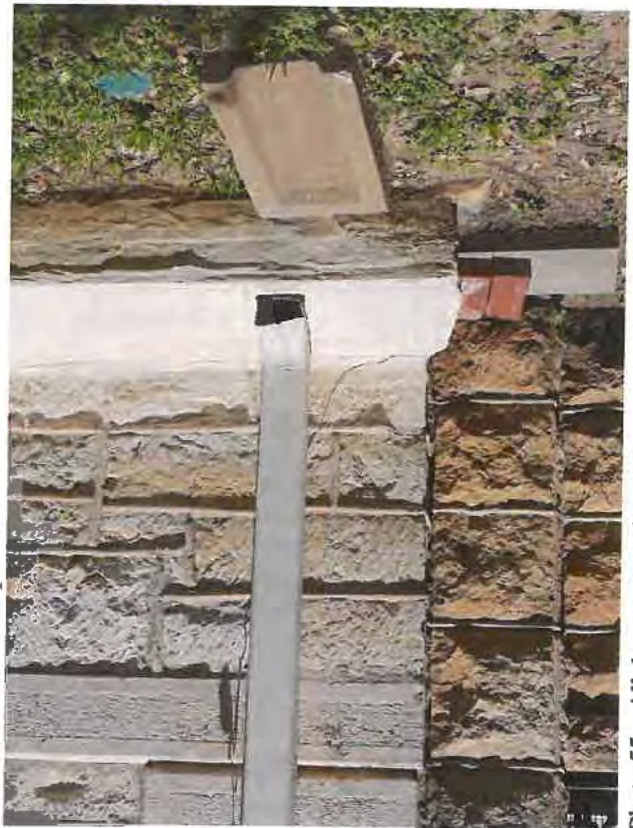
Photo 55: All downspouts should be extended to grade in a manner that directs water away from the building. Note deteriorating waterproof coating on foundation at east elevation.

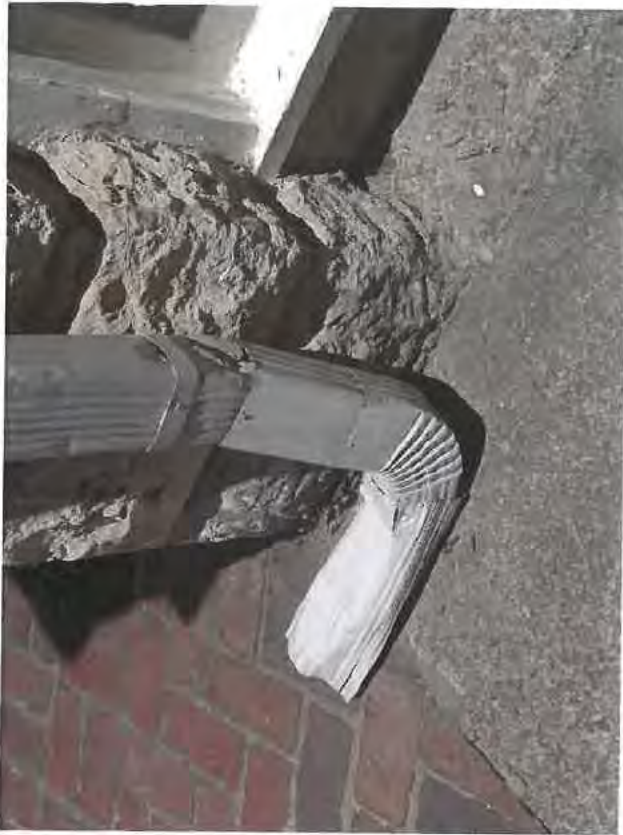
Photo 54: Example of downspout damaged by foot traffic.

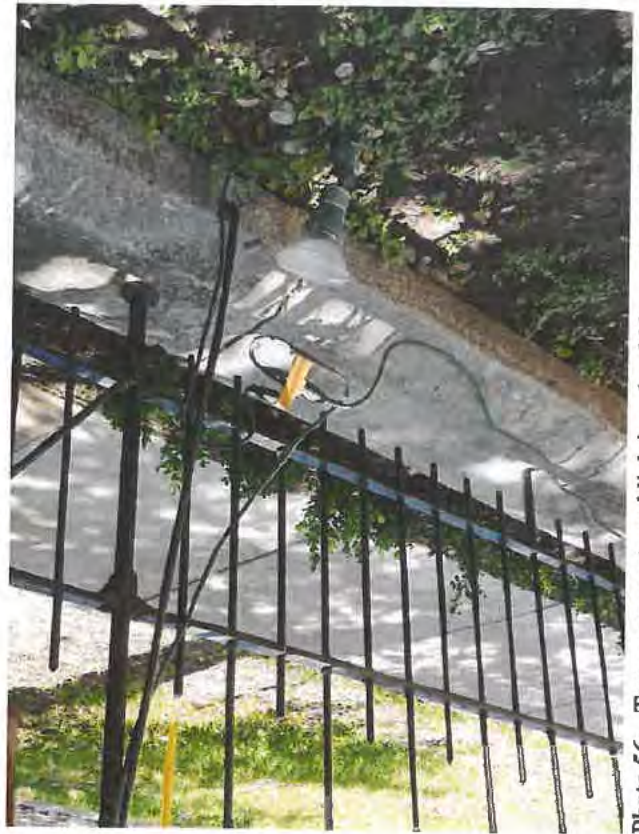
Photo 56: Temporary east yard lighting should be replaced with code-compliant permanent installation.
